# Warranty Guide

## Cause and Effect of Fatigue Failures

## 6. Typical Failures

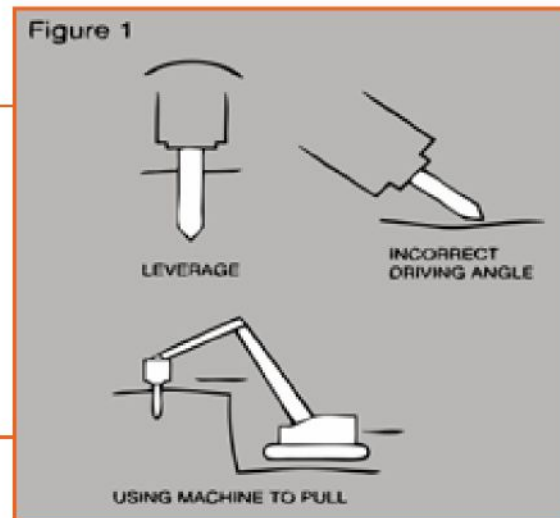
The main cause of increased fatigue stress in a demolition tool is any form of side pressure during service which creates bending. Utilizing the tool as a lever, using the incorrect driving angle or attempting to break ground using the “pull” of the machine are all detrimental to the life of a demolition tool and are to be avoided (see Figure 1).

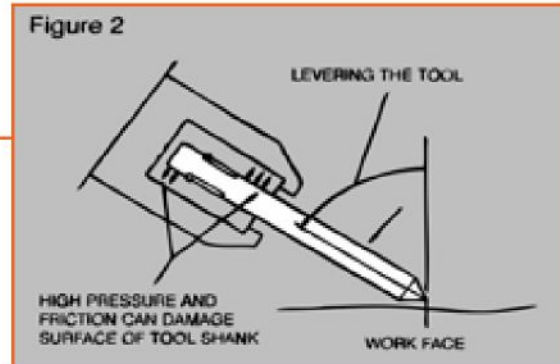
Regular lubrication is essential. Any form of damage to the surface of a demolition tool renders it more liable to suffer fatigue failure. Care must be taken to prevent accidental gouging or contact welding (“galling” or “pickup”) due to contact between the tool and chuck bushings either through lack of lubrication or excessive leverage (see Figure 2).

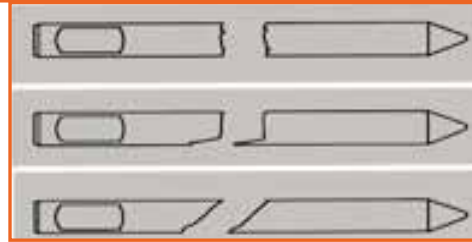
a. Typical fractures caused by excessive bending/leverage of the demolition tool. Warranty claims rejected.

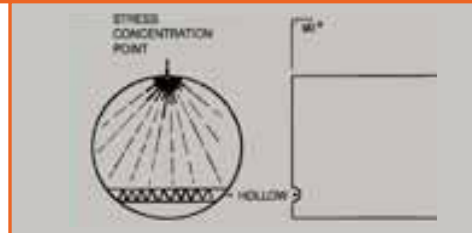
b. Typical of high stress fracture, usually caused by using the tool as an anchor to “pull” the machine. Warranty claims rejected.

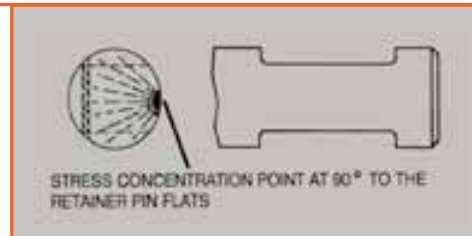
c. Typical fracture caused by levering tool while buried in the burden. Warranty claims rejected.

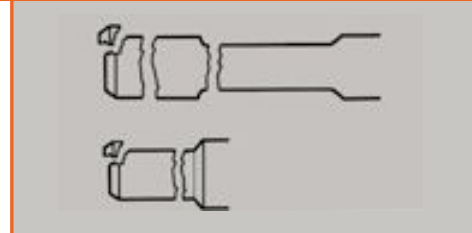
d. Typical fractures caused by blank firing and/or excessive chuck bush wear/damage. Warranty claims rejected.

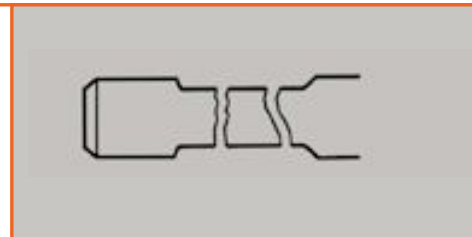
e. Typical fractures caused by blank firing and/or twisting of the tool due to worn/damaged retainer pin. Warranty claims rejected.

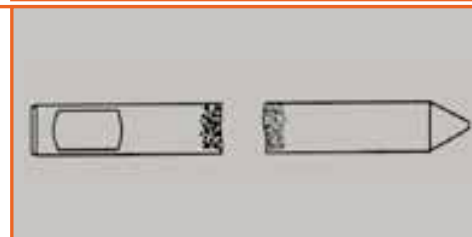
f. Typical fracture caused by lack of lubrication and/or chuck bush wear/damage. Warranty claims rejected.

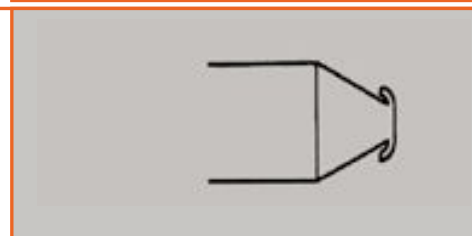
g. Mushrooming: this is caused by driving the chisel or point into hard dense material for too long a period of time without penetration. This generates intense heat, softening the point and causing it to “mushroom”. This is not a manufacturing fault. Warranty claims rejected.

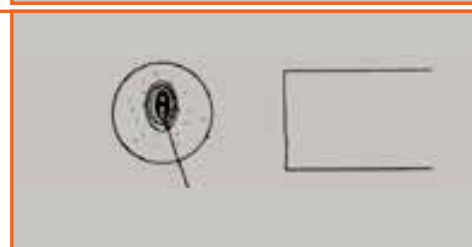
h. Note fatigue lines originate from the internal point, not outer diameter. Very rare failure type due to steel defect. 100% warranty accepted.
